AGUA HEDIONDA 2023 ANNUAL REPORT

Prepared by Ellen Bartlett and Karen Merrill, Preserve Calavera, North San Diego County Watershed Monitoring Program

Agua Hedionda Creek Annual Report 2023

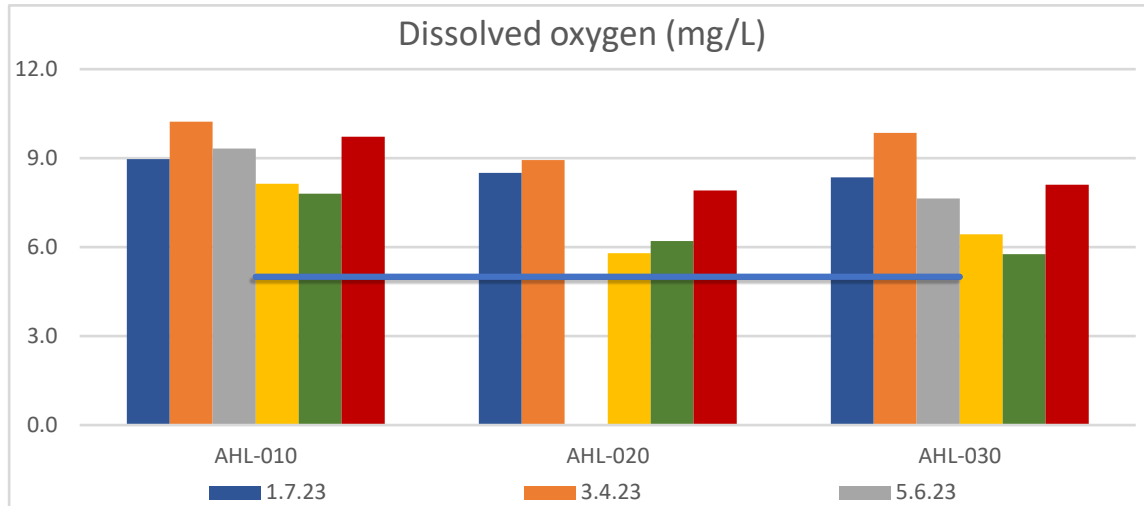
Dissolved Oxygen (DO): San Diego Basin Plan² threshold level for dissolved oxygen is 5.0 mg/L or above. Dissolved oxygen was well above the threshold levels throughout the year. During the warmer months of July and September the oxygen levels did decline as is the yearly pattern and rise again in November.

pH: The pH ranged from 7.01 to 8.5 for all sites. All values fall within the acceptable range for the San Diego Basin Plan of 6.5-8.5.

Although DO did drop when water temperature was at its warmest in the months of July and September, DO remained above threshold for all readings throughout the 2023 year. This was in contrast to previous years when DO consistently dropped below threshold level in July and September. We examined specific water temperature data for past and present to determine if 2023 water temperatures may have been cooler in those months. After going back through prior years' water temperatures for July and September, that does not appear to be the cause of the above threshold readings.

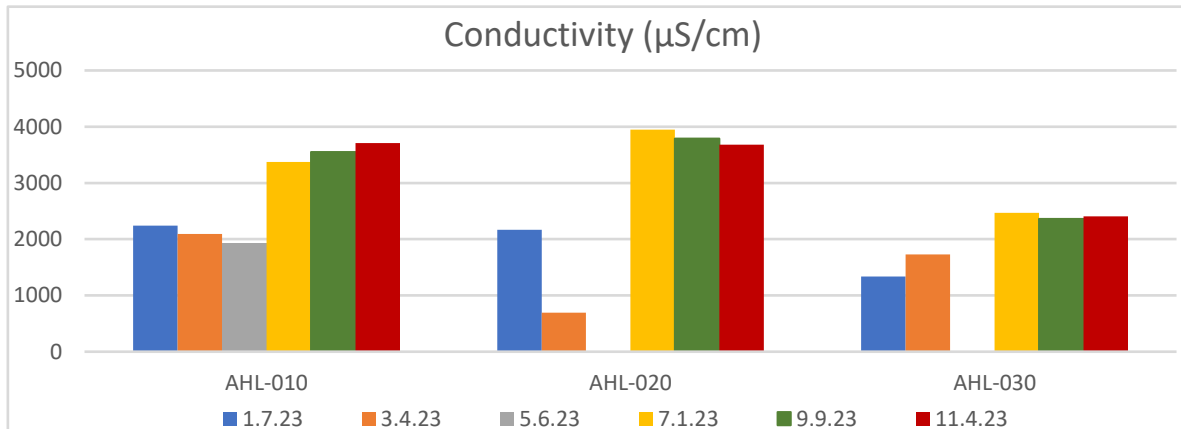
Conductivity: Conductivity fluctuated between 695 - 3950 $\mu\text{S}/\text{cm}$. There is no threshold for conductivity, it merely reflects the amount of dissolved minerals in the water, however, the California Waterboard typically sees levels between 100-2000 $\mu\text{S}/\text{cm}$ in freshwater streams ([Electrical Conductivity/Salinity Fact Sheet](#)).

Sites AHL010 and 020 showed higher values than those typically seen in other freshwater streams in California during the second half of the year. Site AHL030 had conductivity levels in the range more closely aligned with other freshwater streams in California.

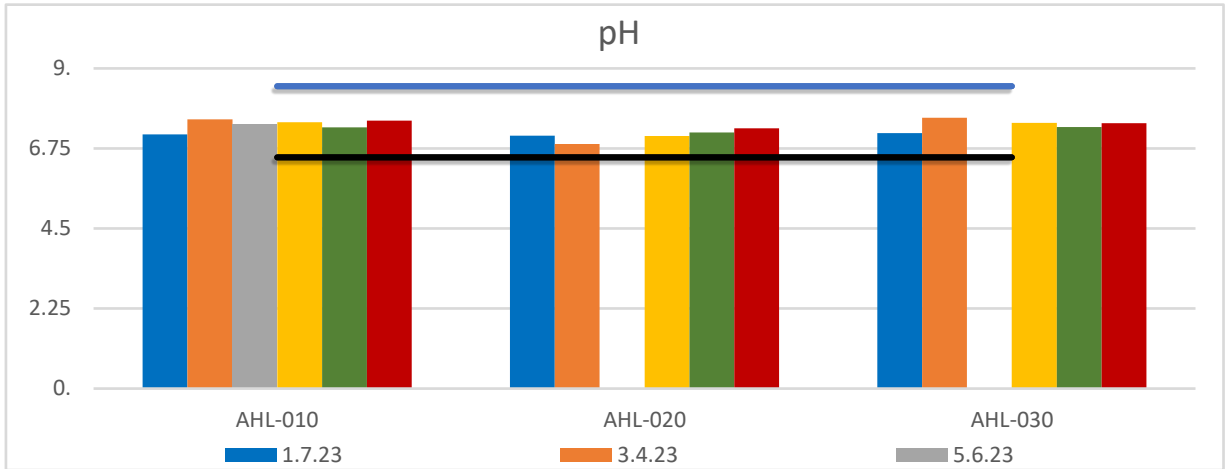
pH: The pH ranged from 7.01 to 8.5 for all sites. All values fall within the acceptable range or the San Diego Basin Plan of 6.5-8.5.

pH continued to fall within the acceptable range for all of 2023; which is consistent with all of the previous testing years. (There was one exception in 2020 as site AHL 010 had one measurement slightly below the acceptable range in September.)

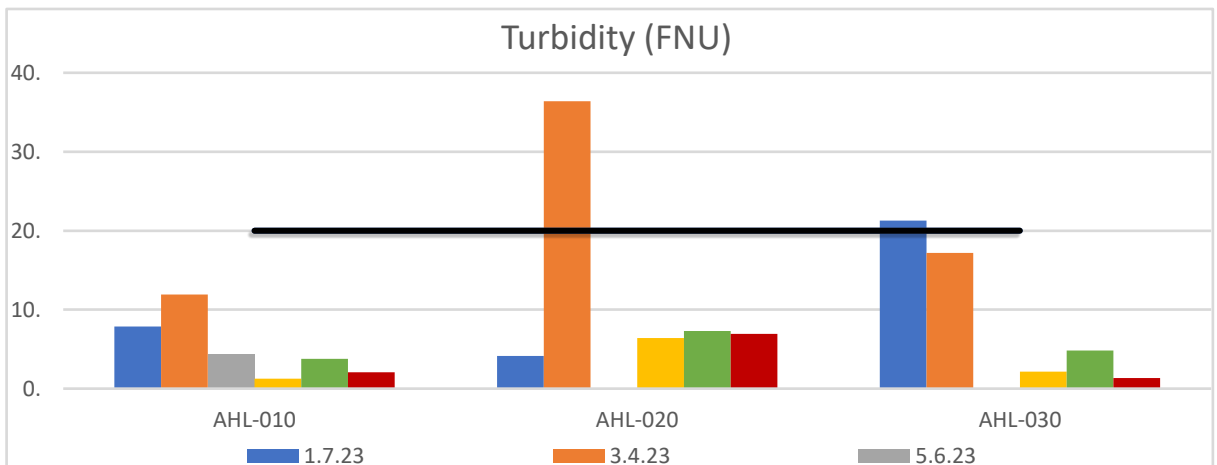
Turbidity: High turbidity can hinder the quantity light penetrating water which may affect photosynthesis. The threshold is 20 FNU.

Turbidity was almost double threshold level (36.40) at site 020 in March. See comments on testing site for this date which describe flooded bridge and stagnant water. Turbidity was slightly above threshold at site 030 in January.

Turbidity measurements for 2023 are similar to past years. The two values that were above threshold were within sites AHL020 (See comments on testing site for this date which describe flooded bridge and stagnant water) and AHL030. In previous years, one or two readings have been above threshold in sites AHL020 and/or AHL030. Site AHL010 continues to remain below threshold for all sampling data.

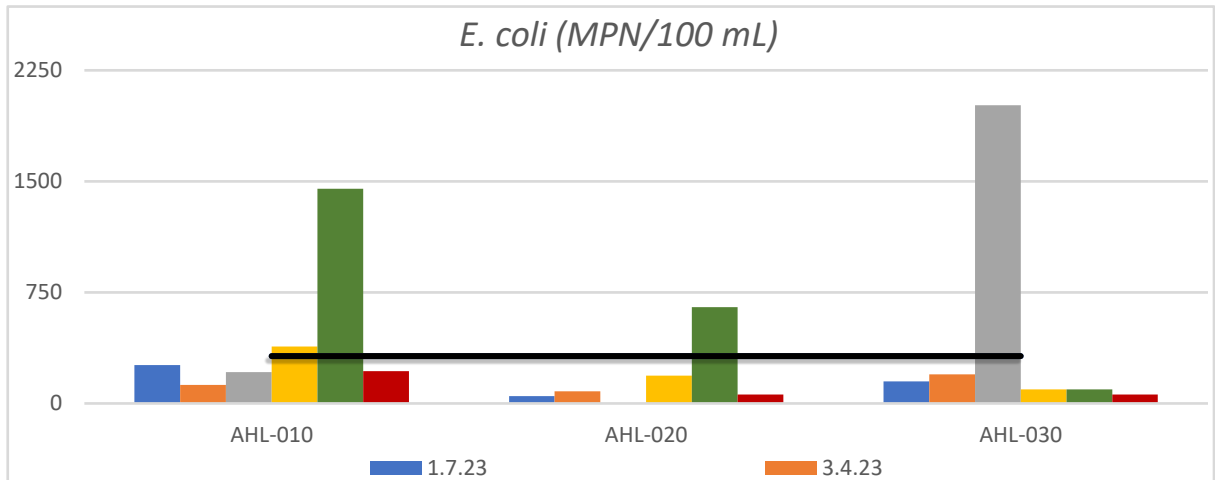
***E. coli*:** Coliforms are a group of bacteria found in the digestive tracts of animals, including humans and their waste products. They are also found in plant and soil material. They may or may not indicate pathogenic bacteria. There is no threshold for these bacteria due to the wide types of sources. *E. coli*, however, is much

more indicative of potential concern as many strains are pathogenic. The test we run, using [IDEXX Quanti-tray/Colilert](#), measures all *E. coli*, pathogenic or not. The threshold for this bacterium is 320 MPN/100 mL³.

Site 010 had two readings above threshold level: July was slightly above threshold at 384 MPN/100 mL³ and September was well above threshold at 1450 MPN/100 mL³. Site 020 was above threshold in September, reading 650 MPN/100 mL³. Site 030 was well above threshold in September, reading 2014 MPN/100 mL³. There was nothing evident at the testing sites to suggest a reason for the above threshold readings.

This year showed above threshold for one date at each site but there is not an identifiable reason for the readings. This is similar to results from prior years.

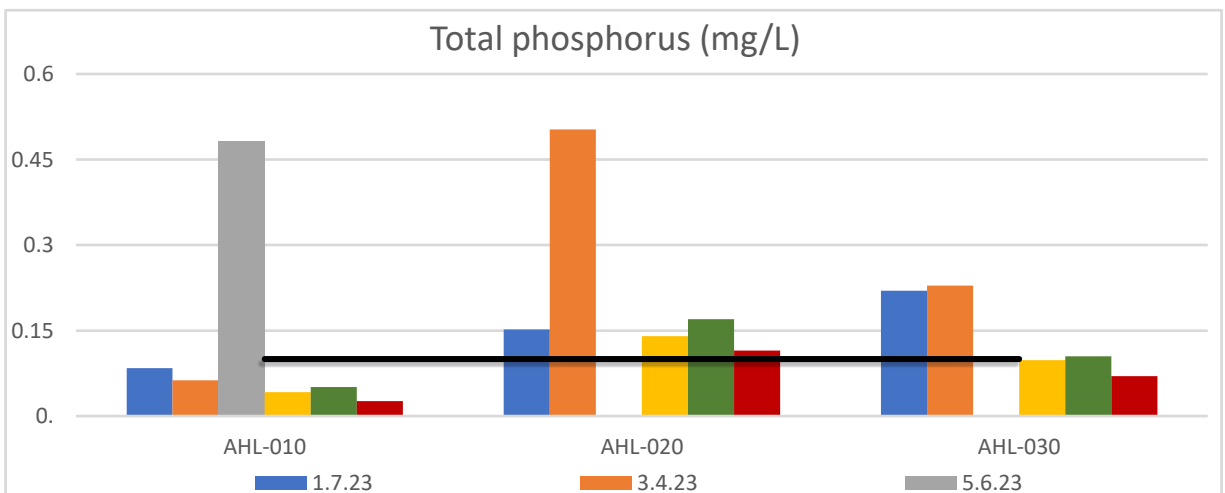
Total Phosphorus: Elevated phosphorus is often the result of fertilizer runoff and can lead to algal blooms. The threshold for San Diego watersheds is 0.1 mg/L³.

All sites had phosphorous levels that were above threshold levels. Site 010 reading was 0.4821 mg/L³ in July and site 020 reading was 0.503 mg/L³. Phosphorous levels at site 030 are also of concern for the first half of the year.

Total phosphorus continues to be difficult to compare time of year and over years. The measurements do not appear to follow any trends overtime. We continue to see over threshold values at all sites and varying times of year. This indicates non-point sources of pollution.

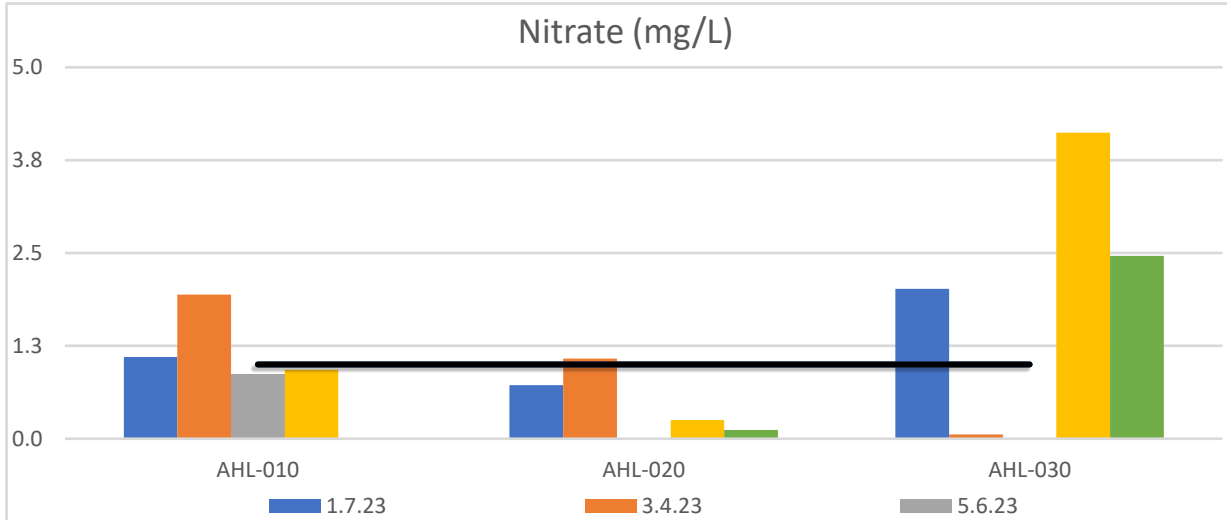
Nitrates: Nitrates generally enter waterways from fertilizer runoff. Threshold level for nitrates is 1.0 mg/L. Values for nitrates fluctuated among the three test sites.

No nitrate testing was done for 9.9.23.

Nitrates values were well above threshold for site 030 for all test dates except for March 4.

There does not appear to be any consistency or trends in nitrate values from year to year but each year continues to have values over threshold. This indicates non-point sources of pollution.

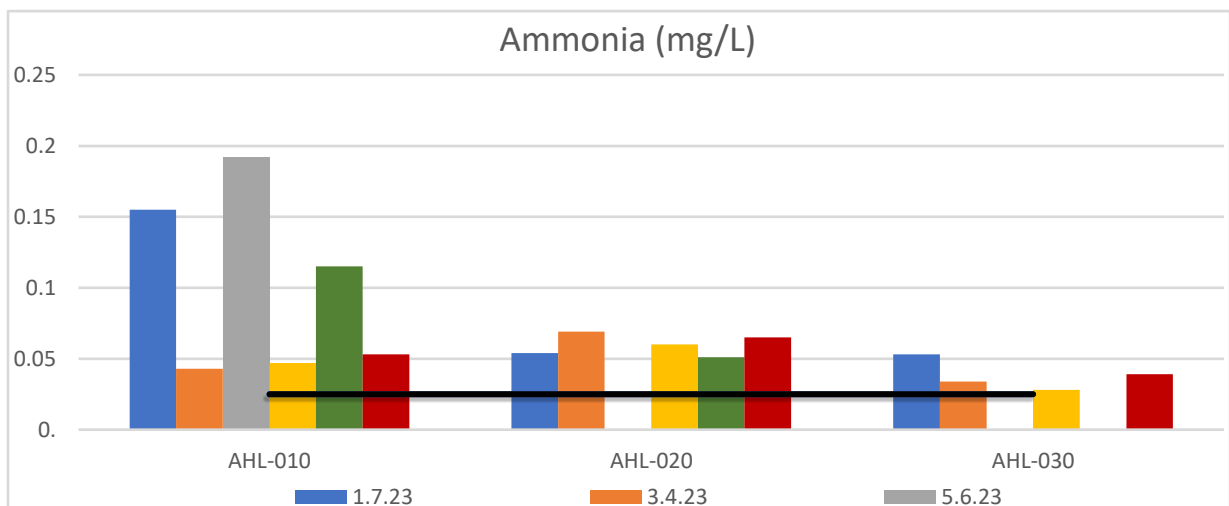
Ammonia- Ammonia is another form of nitrogen. It can cause direct toxic effects on aquatic life. Ammonia can enter waterways through direct means such as municipal effluent discharges and the excretion of nitrogenous wastes from animals, and indirect means such as runoff from agricultural lands. Ammonia's threshold is 0.025 mg/L.

All ammonia levels were above threshold except for site 030 on September 9 with a reading of zero.

Above threshold values for ammonia continue to be a problem at all three test sites in 2023 as it has been in years past. This will continue to be a concern. There does not appear to be any consistency in the values which indicates non-point sources of pollution.

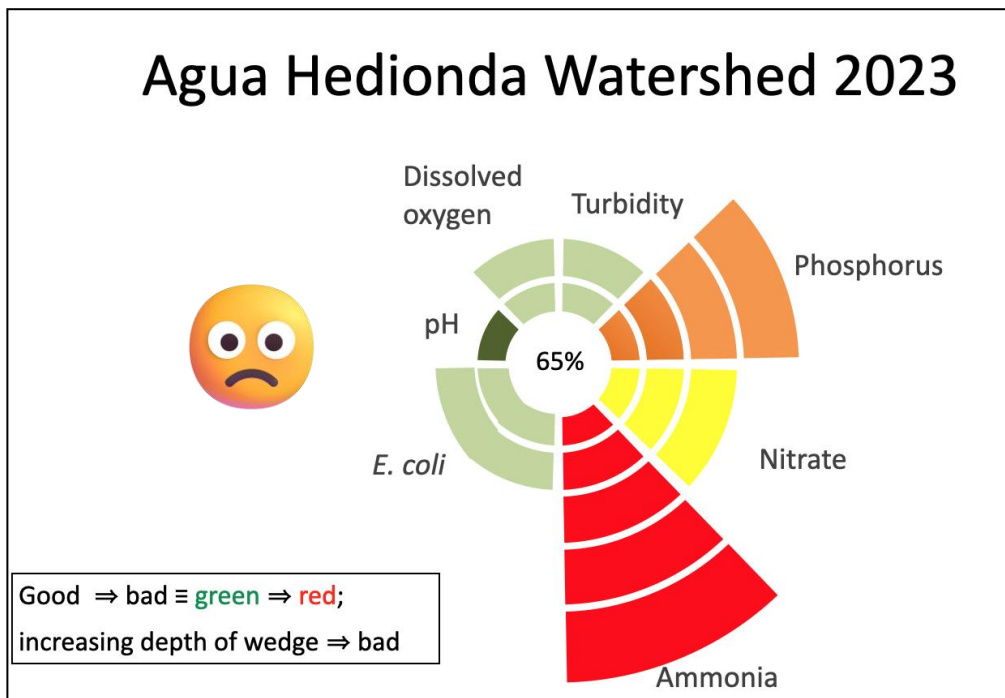
A composite of water quality data can be viewed in a “fan” diagram. A fan diagram is useful as a big picture of the watershed’s overall health, or it can be used to illustrate the health of each test site. The water quality fan diagram was generated from scores (0-5) for each of the seven parameters with an established threshold (pH, DO, turbidity, TP, nitrate, ammonia, and *E.coli*) for each site as well as the watershed as a whole. A composite ranking (as a percentage) is computed from the weighted averages of all parameter scores (with *E. coli* weighted double). Rankings are arbitrarily classified as follows: 90-100% (Excellent); 80-89% (Good); 70-79% (Fair); 60-69% (Poor); >60% (Terrible). The design for the Fan Diagrams is credited to [InfoDiagram](#). Fan diagrams were first added to the WQ Report in 2022.

A composite diagram for the Agua Hedionda Watershed for 2023 is displayed below. The diagram includes data from the three test sites and six test dates. Overall, the Agua Hedionda Watershed scored a grade of Poor. Ammonia stands out as the parameter most in need of improvement. Phosphorus and nitrogen also show a

The overall water quality of the watershed dropped from a Fair rating to Poor. This is only the second year that we have used this evaluation tool so it is too early to look for trends but phosphorous and ammonia stand out in both report cards as the parameters most in need of improvement—though they are both worse in 2023. *E. coli* and DO improved in 2023 but nitrogen was worse.

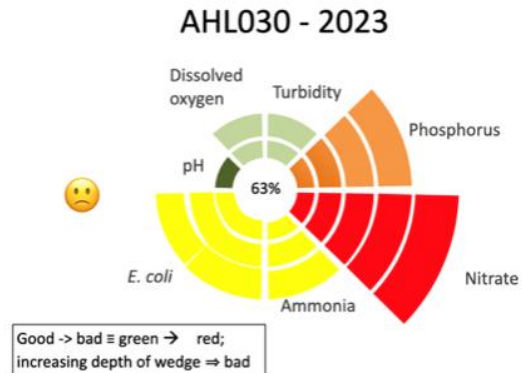
Site AHL030 had a score of Poor at 63% overall. This site is located at south Melrose in Vista under the 78 Freeway bridge. Nitrate is a parameter of highest concern which is denoted by the red wedge.

The fan diagrams help one to visual the differences among the three sites. This is especially evident for nitrate which has a red wedge site AHL030 but has green wedges at sites AHL010 and AHL020.

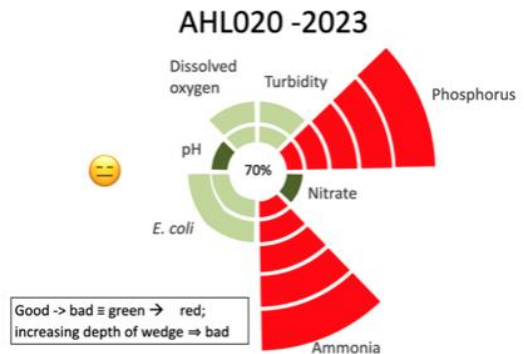
Site AHL020 has a score of Fair at 70% overall but phosphorus and ammonia are parameters of highest concern which are denoted by red wedges. This site is located at Calavera Creek in the Lake Calavera Preserve in Carlsbad.

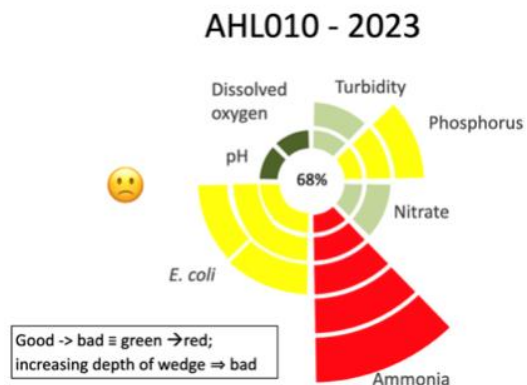
Site AHL010 had a score of Poor at 68% overall. This site is located at the eastern end of lagoon before recreational areas. Ammonia is parameter of highest concern which is denoted by the red wedge.

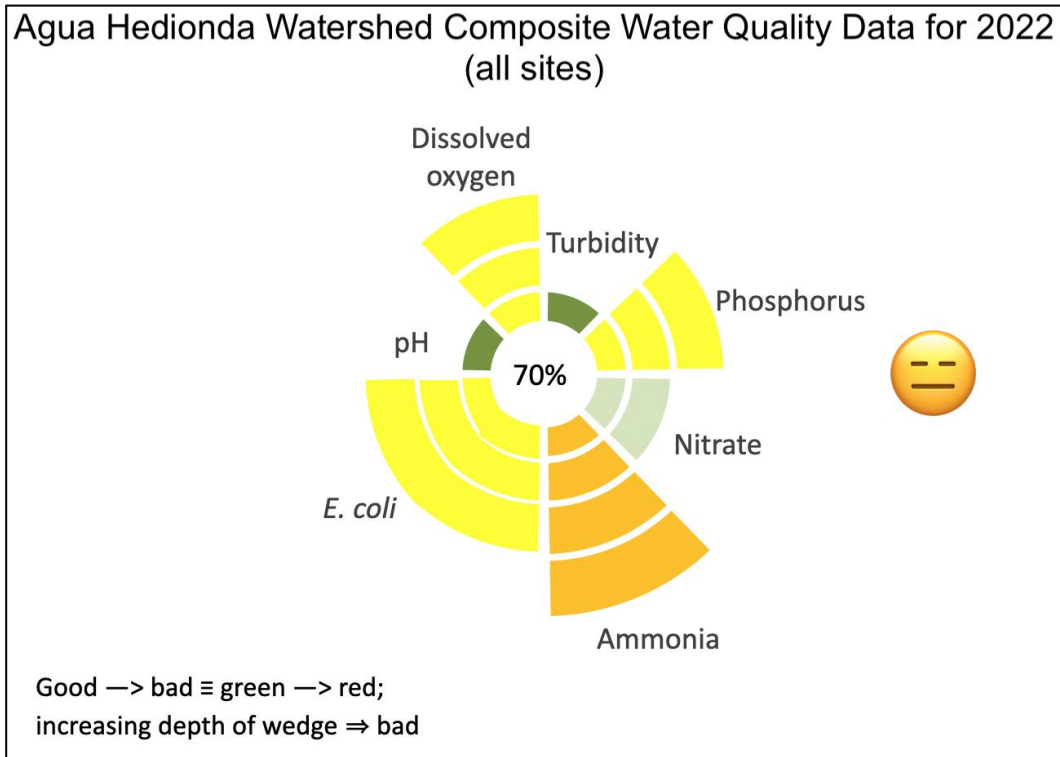
A composite diagram for the Agua Hedionda Watershed for 2022 is displayed below. The diagram includes data from the three test sites and six test dates. Overall, the Watershed scored a grade of Fair. Ammonia stands out

as the parameter most in need of improvement. E. coli, TP and DO are also in need of improvement.

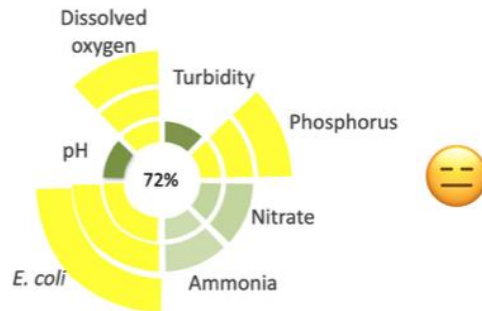
AHL030 Site 2022

Good → bad ≡ green → red;
increasing depth of wedge ⇒ bad

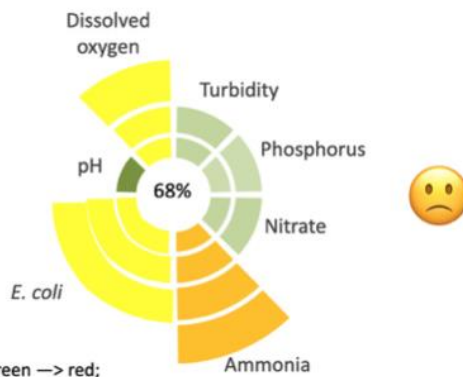
AHL020 Site 2022

Good → bad ≡ green → red;
increasing depth of wedge ⇒ bad

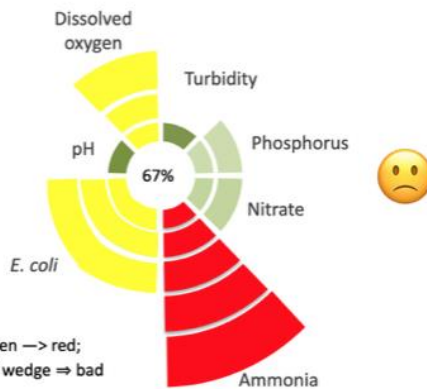
AHL010 Site 2022

Good → bad ≡ green → red;
increasing depth of wedge ⇒ bad
